Dewatering and slope stability in a tropical lignite mine, Neyveli, Tamil Nadu, India

Project Location:	Neyveli, Tamil Nadu, South India
Client(s):	KfW Bankengruppe, Frankfurt (German Development Bank)
Date Completed:	1975
Project Budget:	\$ 40,000

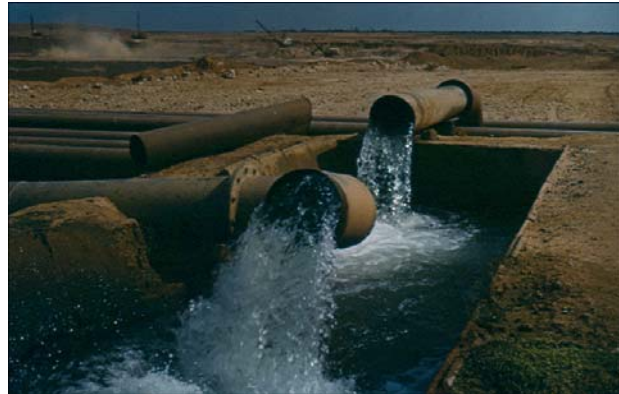
Ground water discharged by submersible pumps.
